Home Inspection Report

315 Woods Run Dr.
Newark, Ohio 43055

Above, Below, & Beyond Home Inspections

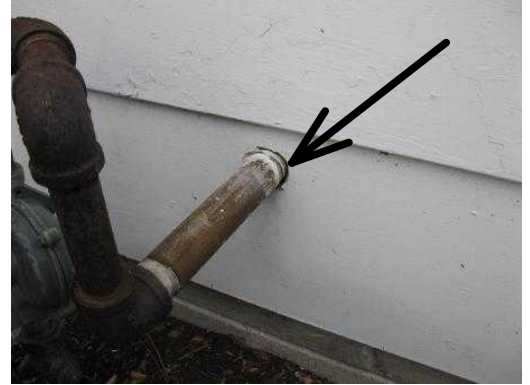
- 11. **Acceptable** Exterior Electric Outlets: 110 VAC
- 12. **Not Inspected** Hose Bibs: Hose bibs not inspected due to outside temperatures below freezing
- 13. **Marginal** Gas Meter: Exterior surface mount, front of home: Gas line needs caulked where it enters the home

2. Gas Meter: Exterior surface mount, front of home: Gas line needs caulked where it enters the home

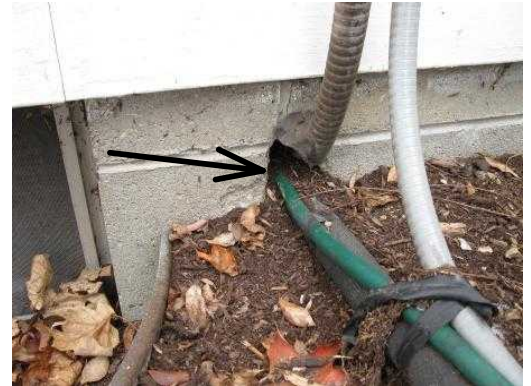
10. **Acceptable** Refrigerant Lines: **Low pressure and high pressure: Coolant lines need caulked where they enter the home.**

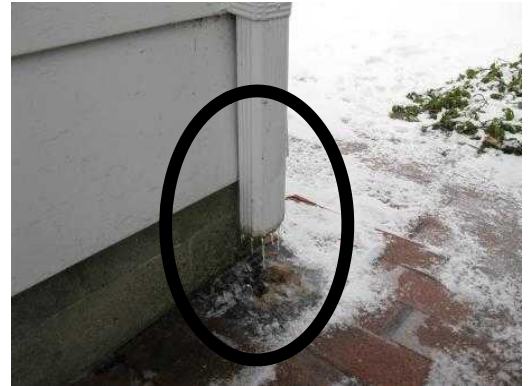
12. Defective Leader/Extension: Missing: Extensions do not extend 6 feet beyond the foundation perimeter. The SE & NE corners of the home and the SW corner of the garage in particular.

1. Leader/Extension: Missing: Extensions do not extend 6 feet beyond the foundation perimeter. The SE & NE corners of the home and the SW corner of the garage in particular.

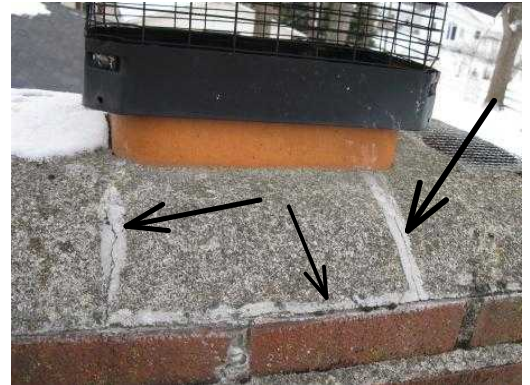
13. Acceptable Chimney: Brick
14. Marginal Flue/Flue Cap: Clay: Cap cracked, repair chimney mortar cap, old sealant should be replaced.

4. Downspouts: Aluminum
5. North Chimney Flue/Flue Cap: Clay: Cap cracked, repair chimney mortar cap, old sealant should be replaced.

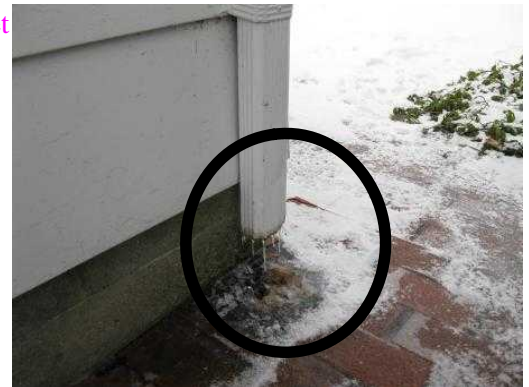
- 6. Acceptable Roof: Asphalt shingle
- 7. Acceptable Roof Structure: 2x4 Rafter
- 8. Acceptable Service Doors: Wood & Glass
- 9. Acceptable Ceiling: Paint and drywall
- 10. Acceptable Walls: Paint and drywall
- 11. Acceptable Floor/Foundation: Poured concrete
- 12. Acceptable Electrical: 110 VAC outlets and lighting circuits
- 13. Not Present Smoke Detector:
- 14. Not Inspected Heating: Gas space heater: Gas space heater not connected to gas line
- 15. Acceptable Windows: Wood double hung
- 16. Acceptable Gutters: Aluminum
- 17. Acceptable Downspouts: Aluminum
- 18. Defective Leader/Extensions: Missing: Extensions do not extend 6 feet beyond the foundation perimeter

2. Attached Garage Door Opener: Genie: Pressure reverse switch on the back of the motor needs adjusted - Safety Concern
3. Attached Garage Leader/Extensions: Missing: Extensions do not extend 6 feet beyond the foundation perimeter

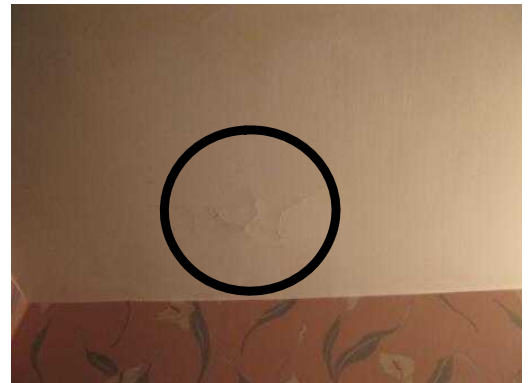
16. **Not Present** Closet:
17. **Acceptable** Ceiling: **Paint and drywall: Evidence of past or present water staining**

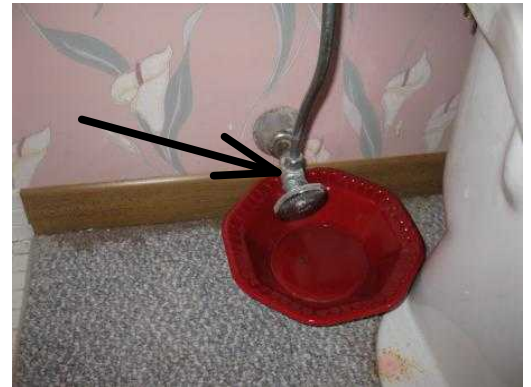
- 24. **Acceptable** Sink/Basin: **Molded single bowl**
- 25. **Acceptable** Faucets/Traps: **Chrome faucet chrome drain**
- 26. **Not Present** Tub/Surround:
- 27. **Acceptable** Shower/Surround: **Ceramic pan ceramic tiles**
- 28. **Not Present** Spa Tub/Surround:
- 29. **Acceptable** Toilets: **1 1/2 Gallon Tank: Fill valve for toilet leaks**

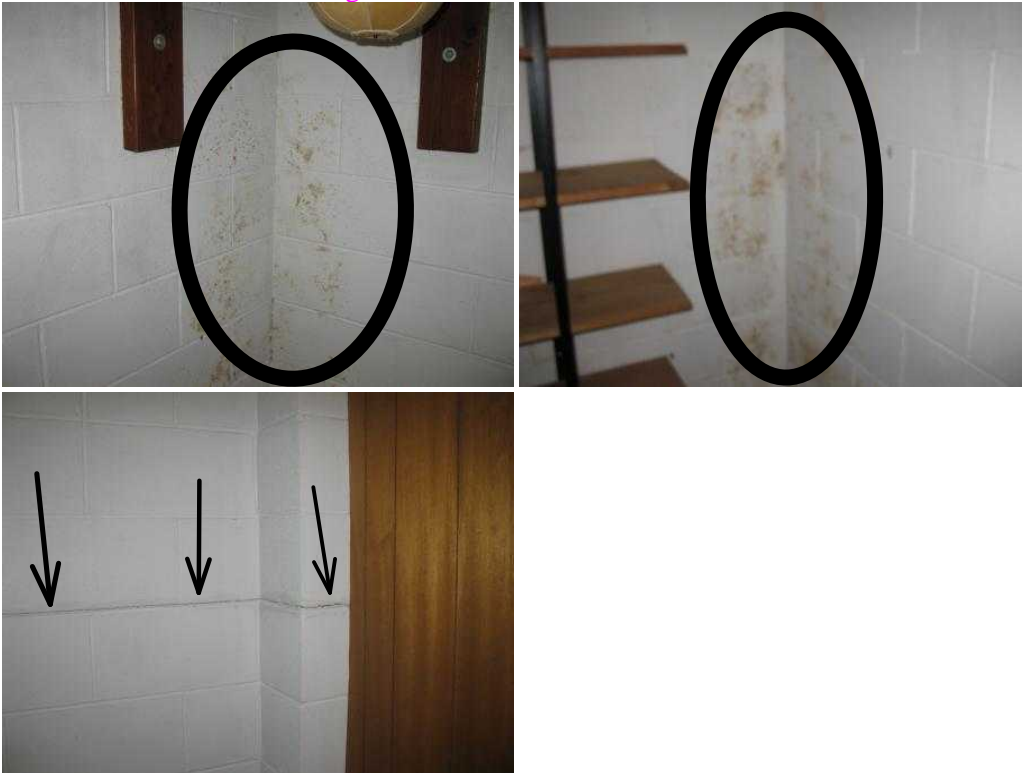
2. **Marginal** Walls: **Wood paneling, Concrete block:** The SE & NE corners of the basement are water stained. I recommend adding additional top soil around the foundation and creating a proper slope (usually 1" drop for every foot away from the foundation) away from the foundation all the way around the entire home. There is a horizontal crack and stair step crack in the East basement wall, I recommend monitoring this area to see if the cracks enlarge.

8. Under main structure Basement Walls: Wood paneling, Concrete block: The SE & NE corners of the basement are water stained. I recommend adding additional top soil around the foundation and creating a proper slope (usually 1" drop for every foot away from the foundation) away from the foundation all the way around the entire home. There is a horizontal crack and stair step crack in the East basement wall, I recommend monitoring this area to see if the cracks enlarge.

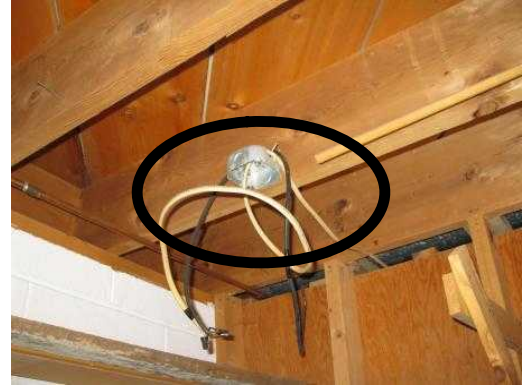
- 5. Acceptable Floor Drain: Surface/Floor drain
- 6. Acceptable Doors: Wood and glass
- 7. Acceptable Windows: Metal casement
- 8. Safety Concern Electrical: 110 VAC outlets and lighting circuits: **There is an electrical junction box in the basement ceiling with no cover on it, this is a Safety Concern.**

4. Under main structure Basement Electrical: 110 VAC outlets and lighting circuits: There is an electrical junction box in the basement ceiling with no cover on it, this is a Safety Concern.

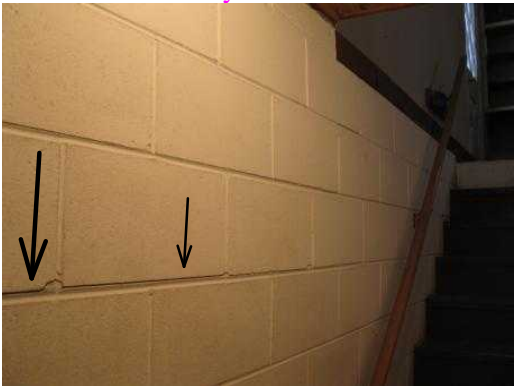
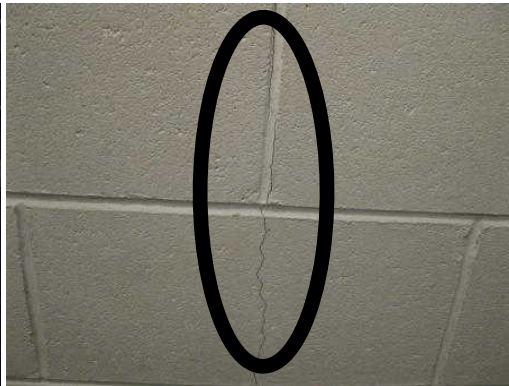
Basement Stairs/Railings: (continued)

- 9. Not Present Smoke Detector:
- 10. Not Present Radon Blower Installed
- 11. Acceptable HVAC Source: Central HVAC
- 12. Not Present Vapor Barrier:
- 13. Not Present Insulation:
- 14. Acceptable Ventilation: Windows
- 15. Not Present Sump Pump:
- 16. Marginal Moisture Location: North and South East corners
- 17. Marginal Basement Stairs/Railings: Wood stairs & handrails: **The outside wall in the stairway going down to the basement has stair-step, horizontal, & vertical cracks in it. They appear to be old, I suggest monitoring the cracks to see if they start to worsen.**

9. Under main structure Basement Moisture Location: North and South East corners
10. Under main structure Basement Basement Stairs/Railings: Wood stairs & handrails: The outside wall in the stairway going down to the basement has stair-step, horizontal, & vertical cracks in it. They appear to be old, I suggest monitoring the cracks to see if they start to worsen.

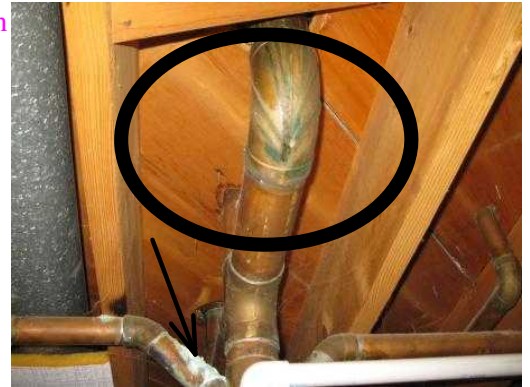
1. **Acceptable** Service Line: **Copper**
2. **Acceptable** Main Water Shutoff: **Basement**
3. **Acceptable** Water Lines: **Copper, PVC**
4. **Marginal** Drain Pipes: **Copper: The main copper drain line is leaking in the basement, the joints in the line probably need to be re-soldered. And there is some corrosive build-up on the lines.**

11. Drain Pipes: Copper: The main copper drain line is leaking in the basement, the joints in the line probably need to be re-soldered. And there is some corrosive build-up on the lines.
